Accessibility Advisory Group – Site Visit Report

Royal Cornwall Hospital, Truro

Thursday 28 November 2024

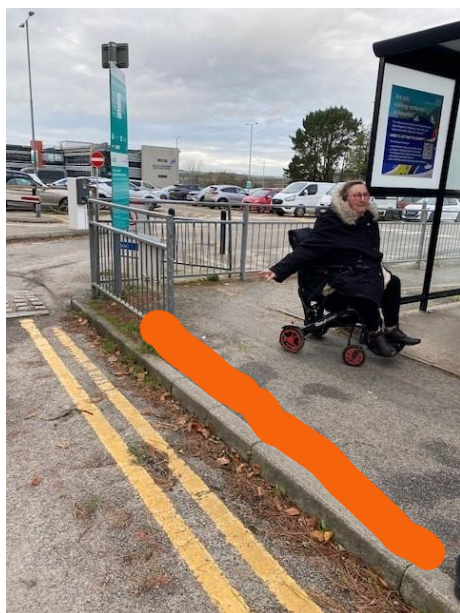
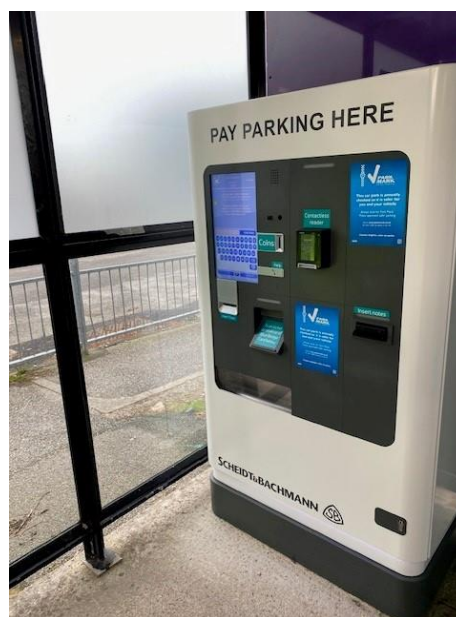
The group noticed immediately that members of the public, including ourselves, were needing to step into the road to avoid congestion.

The group identified that the fencing could be extended along the roadside up to the crossing to ensure people are not stepping into the way of traffic – as depicted in the photo below.

The group identified that the payment station would be best rotated through 90 degrees and moved to the centre of the shelter.

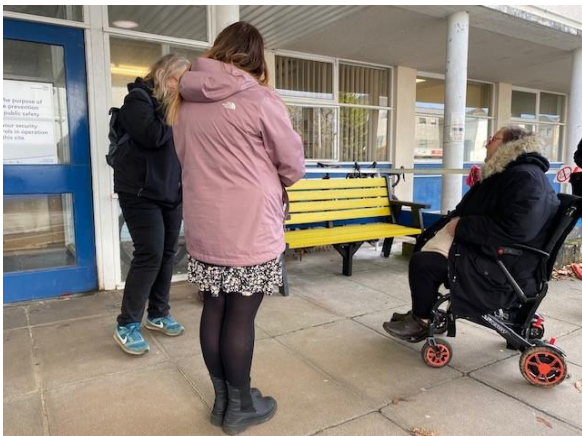
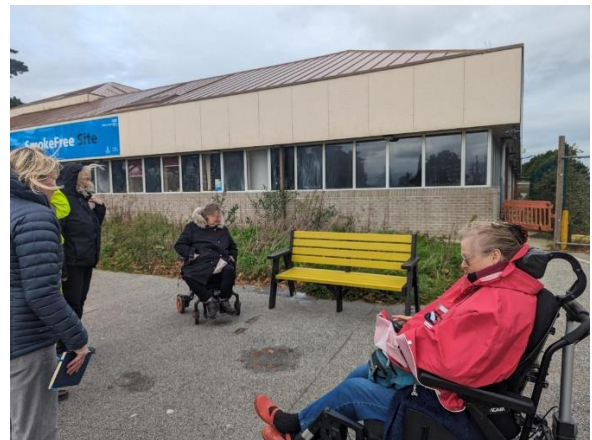
The group visited the locations of the newly purchased and installed exterior benches. These are located outside the Trelawny Entrance (next to the drop off zone), outside the entrance to the Tower Block (next to Eye Clinic) and outside the Princess Alexandra Wing. See images below:

These benches are weather, fireproof and easily moved. The group thought the locations were well chosen and that the colour was great. All were being used by visitors/patients during our visit. No Smoking signs are being added.

It was suggested that if further benches are purchased and installed, that come could be higher; these ones felt low to some trialling them. It was also suggested that accessible picnic benches would benefit the hospital site. The AAG will email the suggestion to the RCHT Charity team.

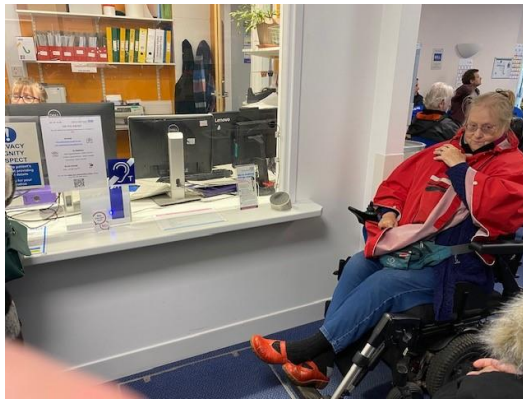
The height of the reception desk is a great height for wheelchair users, however it was pointed out that the receptionists had PC Monitors in front of their faces, meaning patients/visitors would be unable to have face to face communication.

Similarly in other areas of the hospital, reception desks often had lowered areas for wheelchair heights but that they were used to place printers on! Or some receptionists did not realise what they were used for. Receptionist training was suggested; to be taken forward to the EDI team.

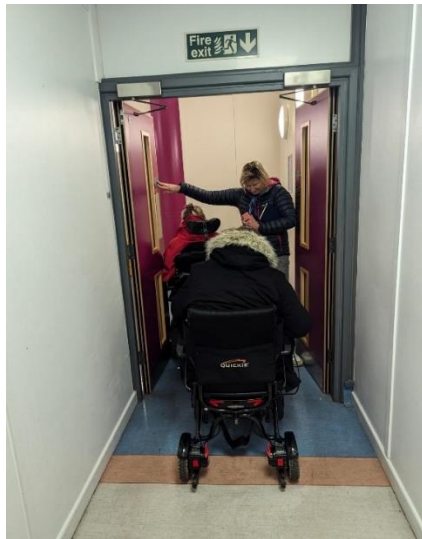
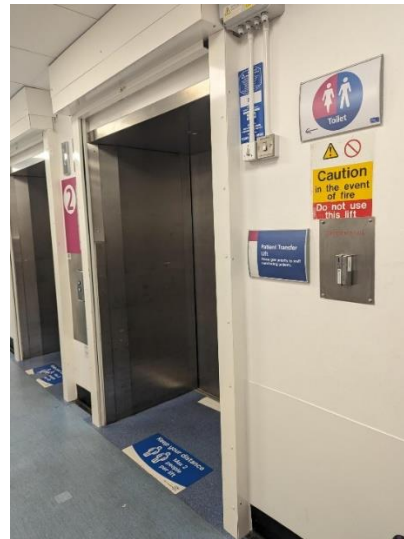
They also noted that there is still nothing to show which lift would be used in case of a fire and that there is no call alarm in the stair well. This means that if someone with limited mobility found themselves in the stair well during a fire, they have no way of telling anybody they were there.

It was felt that there remained a lack of signage in both Trelawny Wing and Tower Block explaining what to do in the event of a fire. The group also noted the heavy fire doors leading to the stairwell (hard for less able bodied users to open).

The group felt it would be useful to know more about the Fire Safety Improvement works currently being undertaken in the Tower Block at the moment and understand better the emergency procedures in case of a fire. Some members of the AAG said that they would volunteer to be involved in Fire Evacuation Training, to gather an insight on procedures.

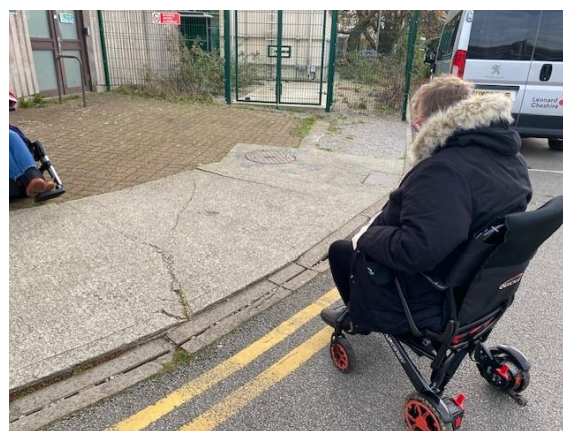
On our way from the Link Corridor (southside entrance) to the Tower Block Eye Unit entrance, it became clear that there is a lack of drop curbs. One of the drop curbs was not low enough, making it difficult for a member of the group to cross the road, in a wheelchair. It was also pointed out that a colour differentiation on the drop curbs would be helpful.

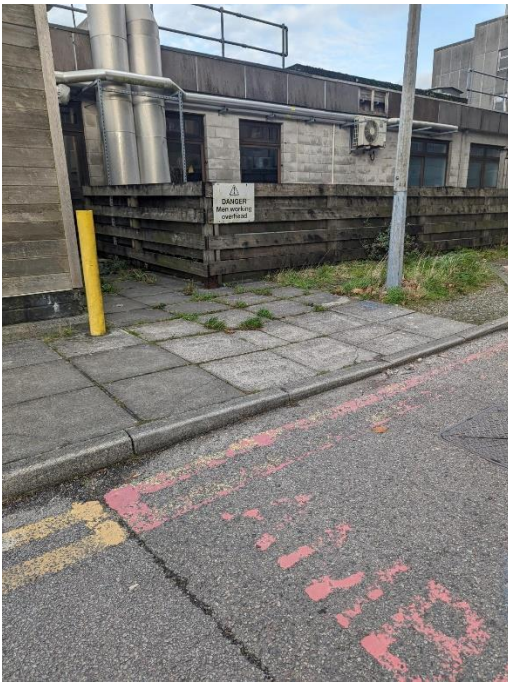
This image shows a lack of drop curb, despite there being a drop curb opposite this on the other side of the road. Meaning crossing from one side to the other is not possible in a wheelchair, in this location.

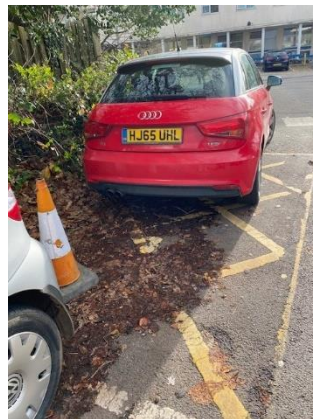
It was also noted that there is also a lack of hatching around the newly created accessible parking bays, opposite the ambulance parking (ED's accessible spaces). And there was hatching, the debris needed clearing.
